ABORIGINAL DUE DILIGENCE ASSESSMENT REPORT

RESIDENTIAL SUBDIVISION OF LOT 7025 DP1020631, LOT 7332 DP1166365, LOT 7317 DP1166614 AND WORKS WITHIN LOT 1 DP1077961

FORBES, NSW

JANUARY 2024

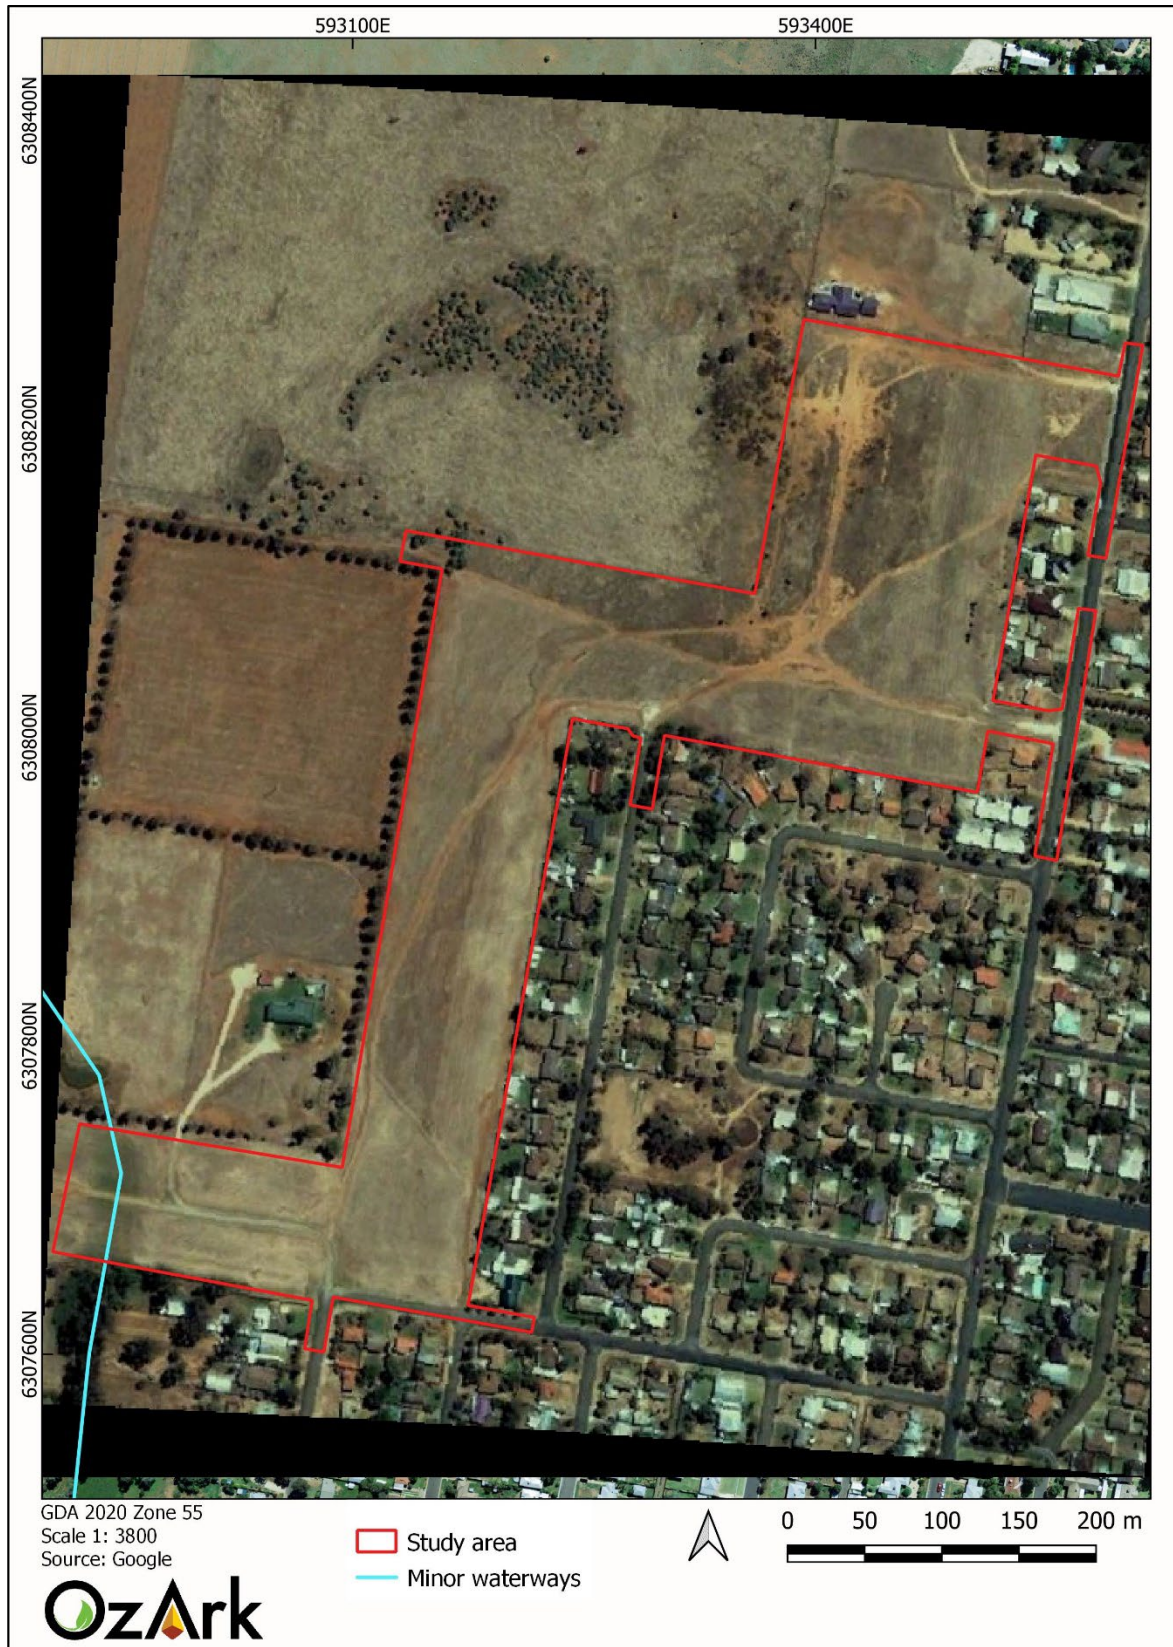
Figure 2-1: 2006 aerial showing historic ploughing within the study area.

Aerial imagery of the study area dating to 2006 shows most of the study area within the lots has been subject to ploughing (**Figure 2-1**). Further, parts of the study area have been impacted by the construction of sealed roads and graded tracks. Therefore, it could be considered that most of the proposed work is occurring in ‘disturbed land’.

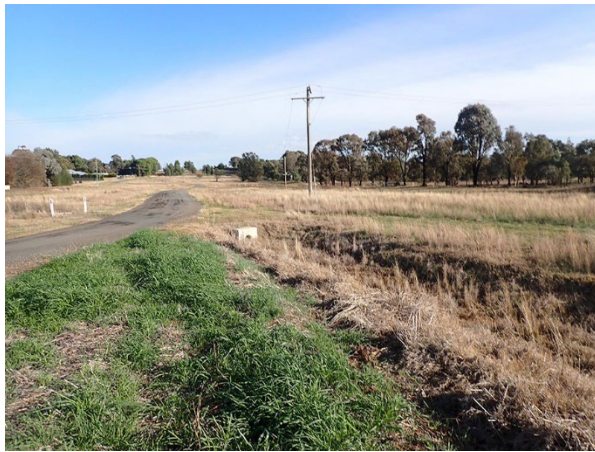
The study area was confirmed as being situated on a gently undulating landform which has undergone previous ground disturbances including sealed and unsealed road construction and grading, overhead electricity transmission lines and historic ploughing (**Plate 1**). Drainage culverts and subsurface gas pipelines are also present across the study area (**Plate 2**).

Plate 1: View west of existing study area disturbances.

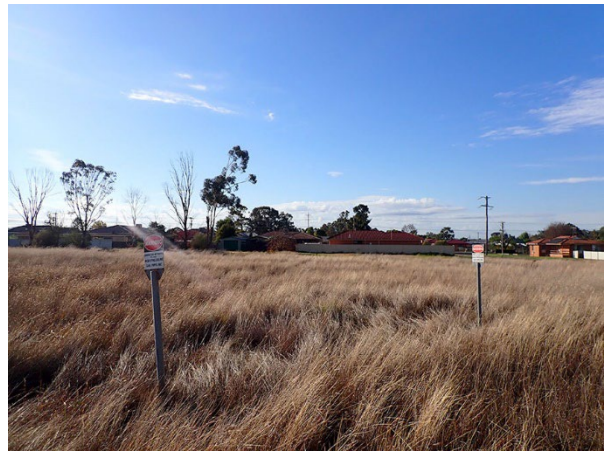
Plate 2: View east of subsurface gas pipeline warning signs.

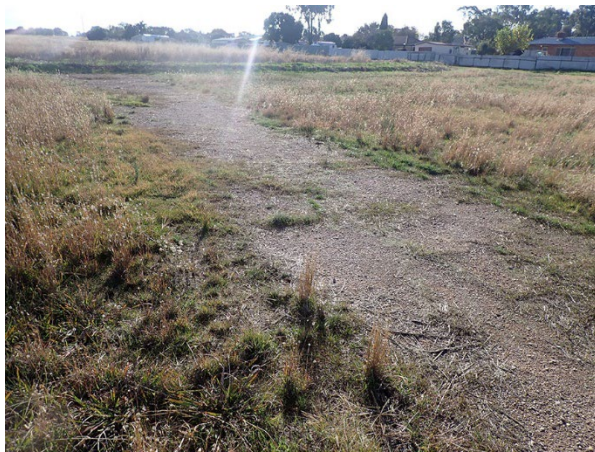
The dense ground cover decreased the overall level of ground surface exposure (GSE) across the study area, averaging 10-20% (**Plate 3**). However, within larger areas of GSE such as along unsealed tracks, higher ground surface visibility (GSV) was observed, averaging 90-100% (**Plate 4**).

Plate 3: View northeast of GSE on and off an unsealed track within the study area.

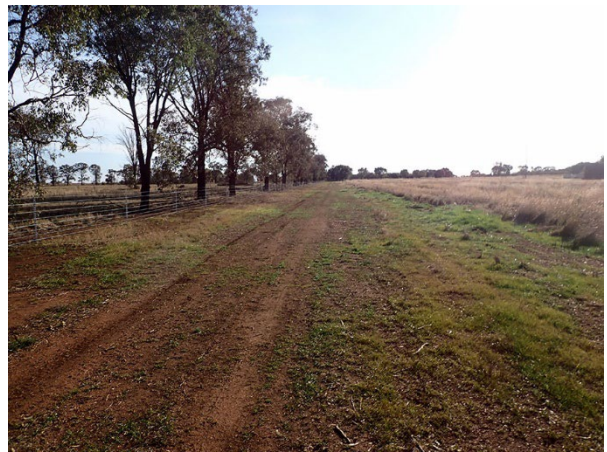
Plate 4: View north of increased GSV within an area of exposure.
