# Preliminary Geotechnical Investigation

Farnell Street, Forbes, NSW 2871

Prepared for: Land and Housing Corporation c/- ADW Johnson Pty Ltd  
EP3269.001v2 17 January 2024

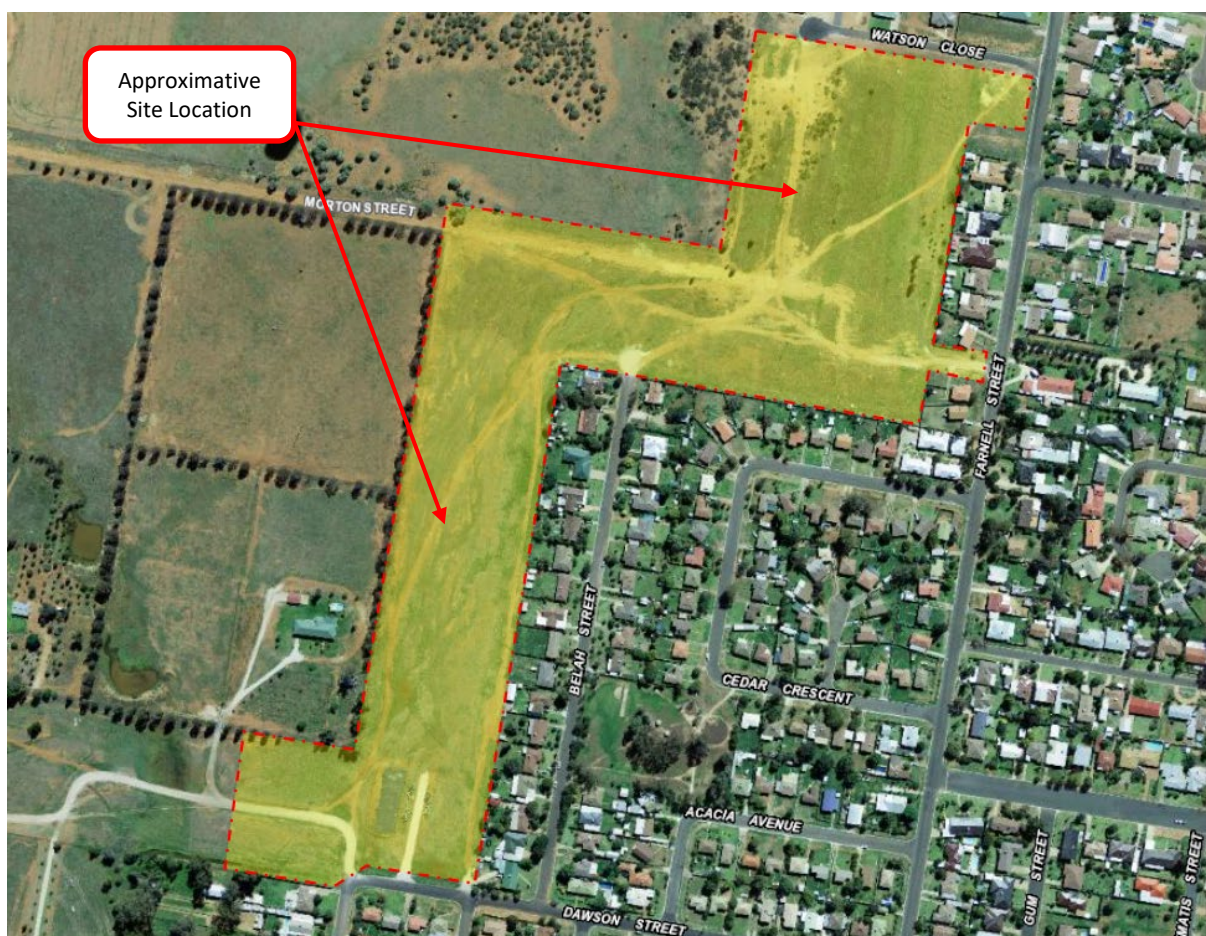
Figure 1. Site Location (excerpt from SIX maps)

Site drainage is assumed to be overland flow via surface contours flowing from the southern portion of site to the northern boundary. The Site location is shown in Figure 1, an excerpt from SIX maps.

| Figure 1. | Site Location (excerpt from SIX maps) ..... | 2 |

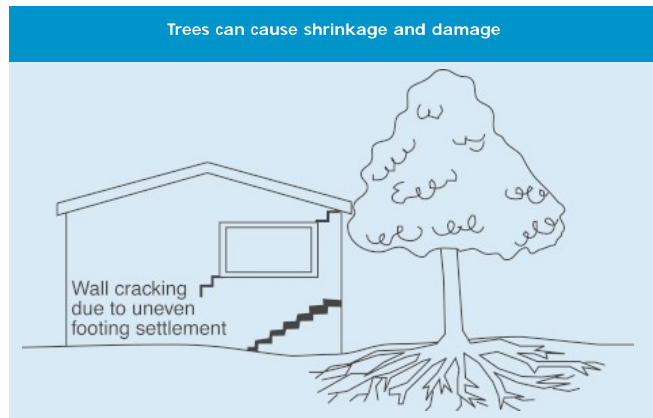
As the moisture absorption process completes its journey to the innermost areas of the building, the internal footings will rise. If the spread of moisture is roughly even, it may be that the symptoms will temporarily disappear, but it is more likely that swelling will be uneven, creating a difference rather than a disappearance in symptoms. In buildings with timber flooring supported by bearers and joists, the isolated piers will rise more easily than the strip footings or piers under walls, creating noticeable doming of flooring.

As the weather pattern changes and the soil begins to dry out, the external footings will be first affected, beginning with the locations where the sun's effect is strongest. This has the effect of lowering the external footings. The doming is accentuated and cracking reduces or disappears where it occurred because of dishing, but other cracks open up. The roof lines may become convex.
