ARBORICULTURAL IMPACT ASSESSMENT REPORT FARNELL ST, FORBES

14 December 2023

Version 3

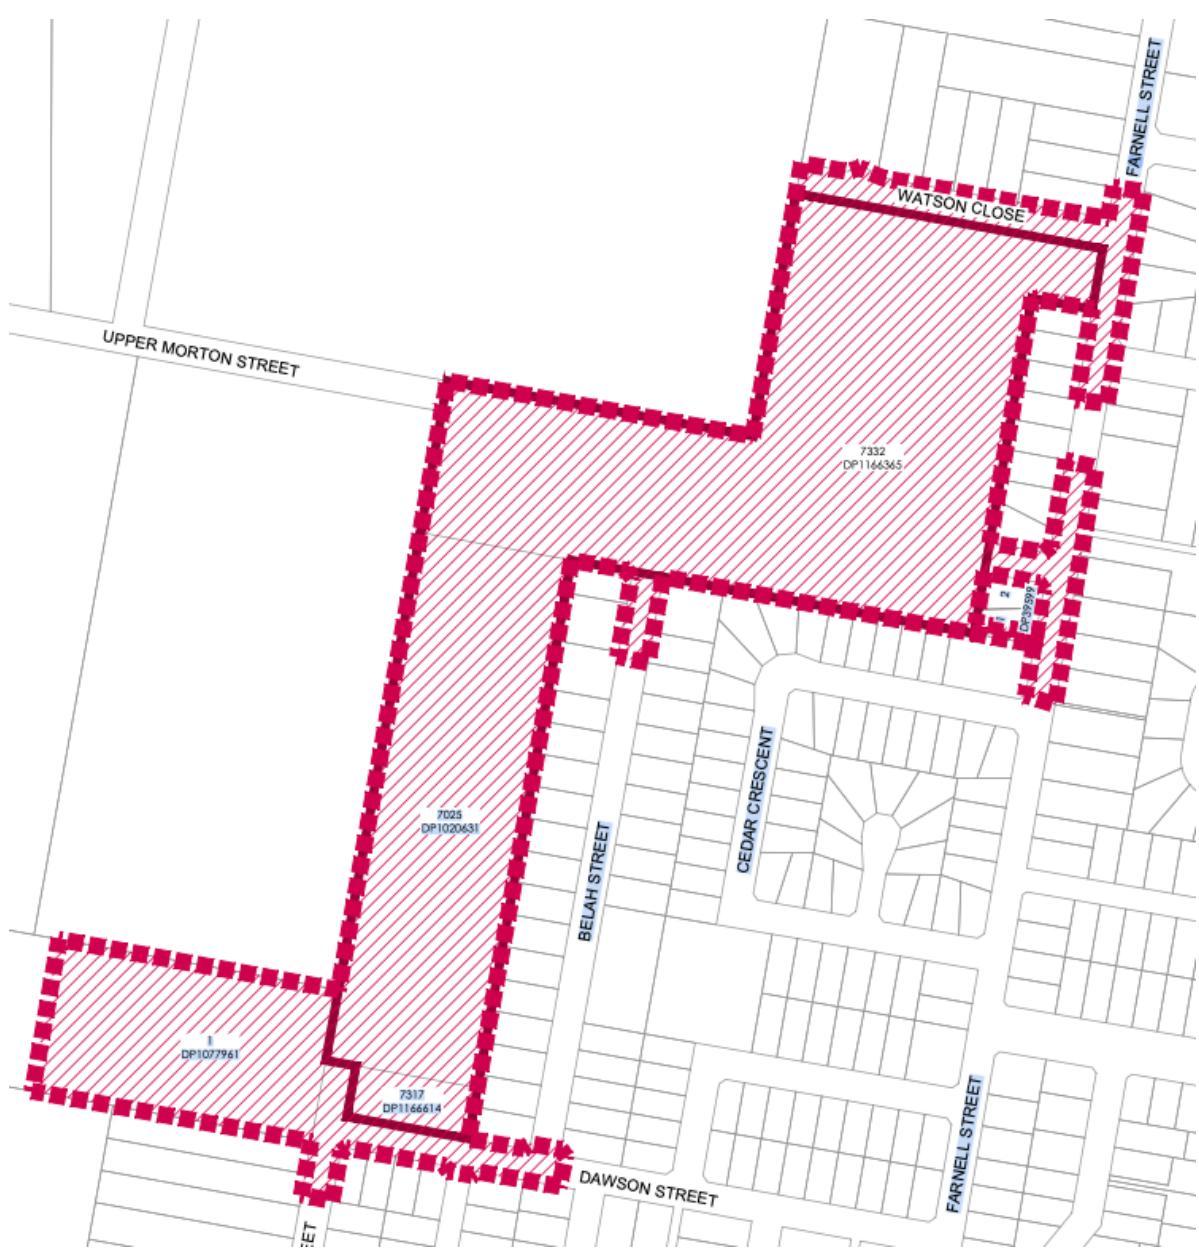
Figure 1 The area marked Red shows the onsite area considered for this report.

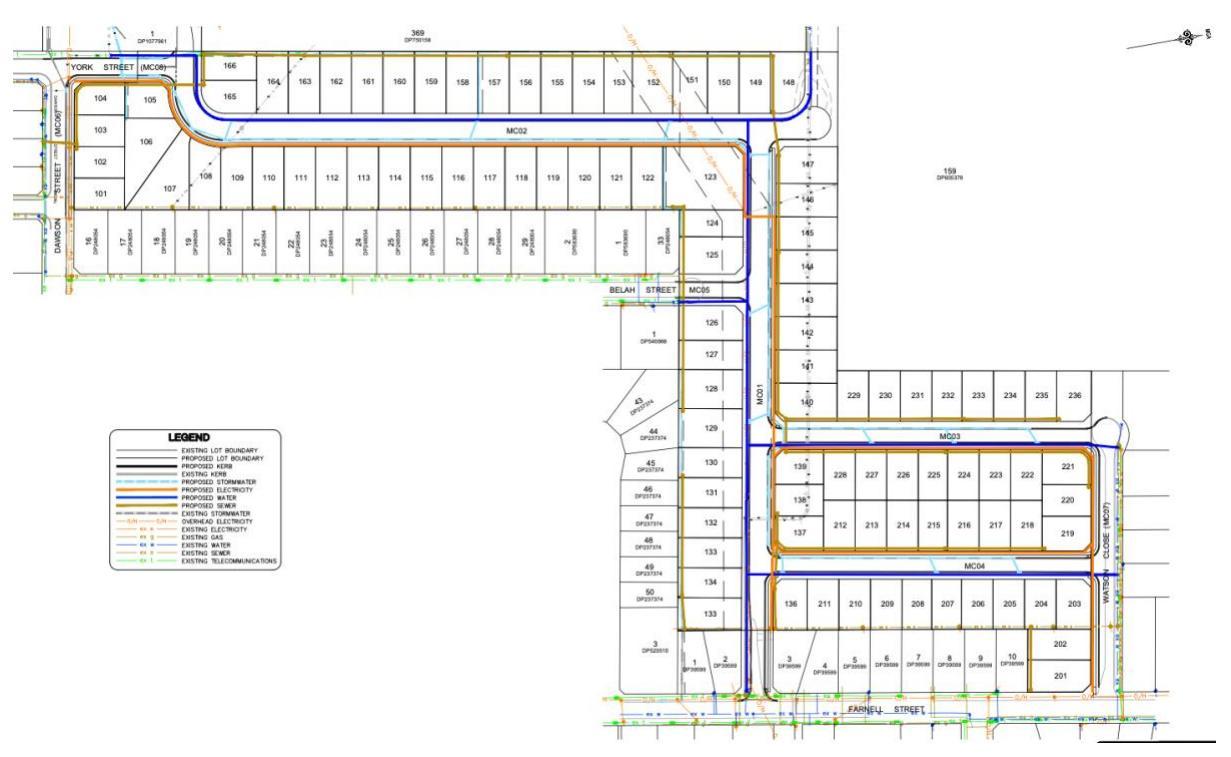
Figure 2 Servicing Plan, showing proposed stormwater (light Blue dash line) and sewer (Brown line).

A proposed stormwater and sewer line will be installed along the western boundary, adjacent to Lot 369, and the south-eastern boundary north of Cedar Crescent.

The proposed stormwater trench will be offset from the property boundary by 1.7m.

The proposed sewer line trench will be installed beyond the adjacent stormwater trench and further away from the boundary.

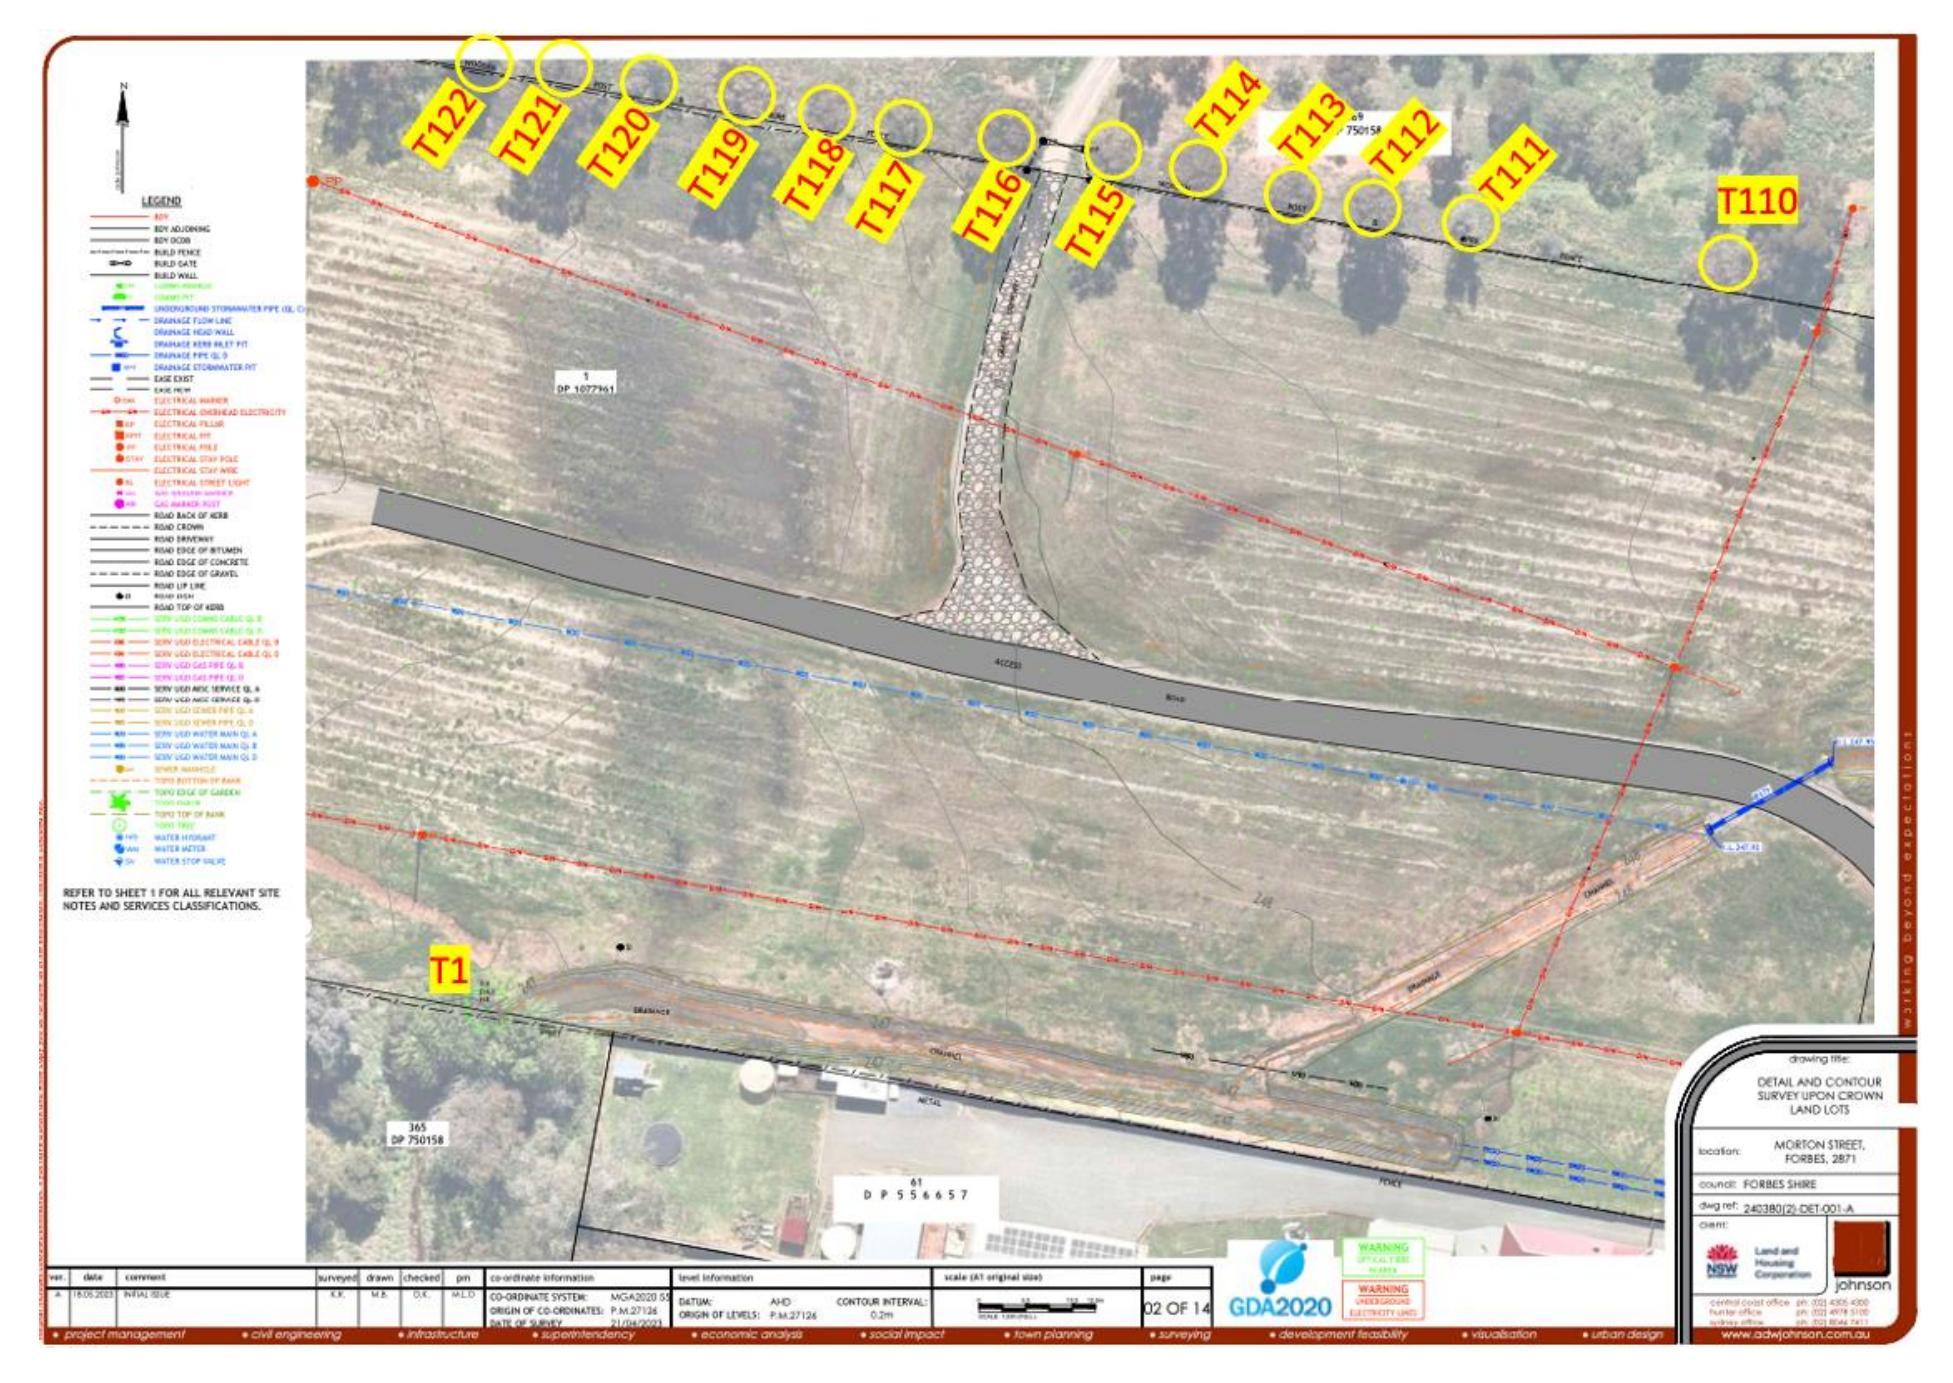
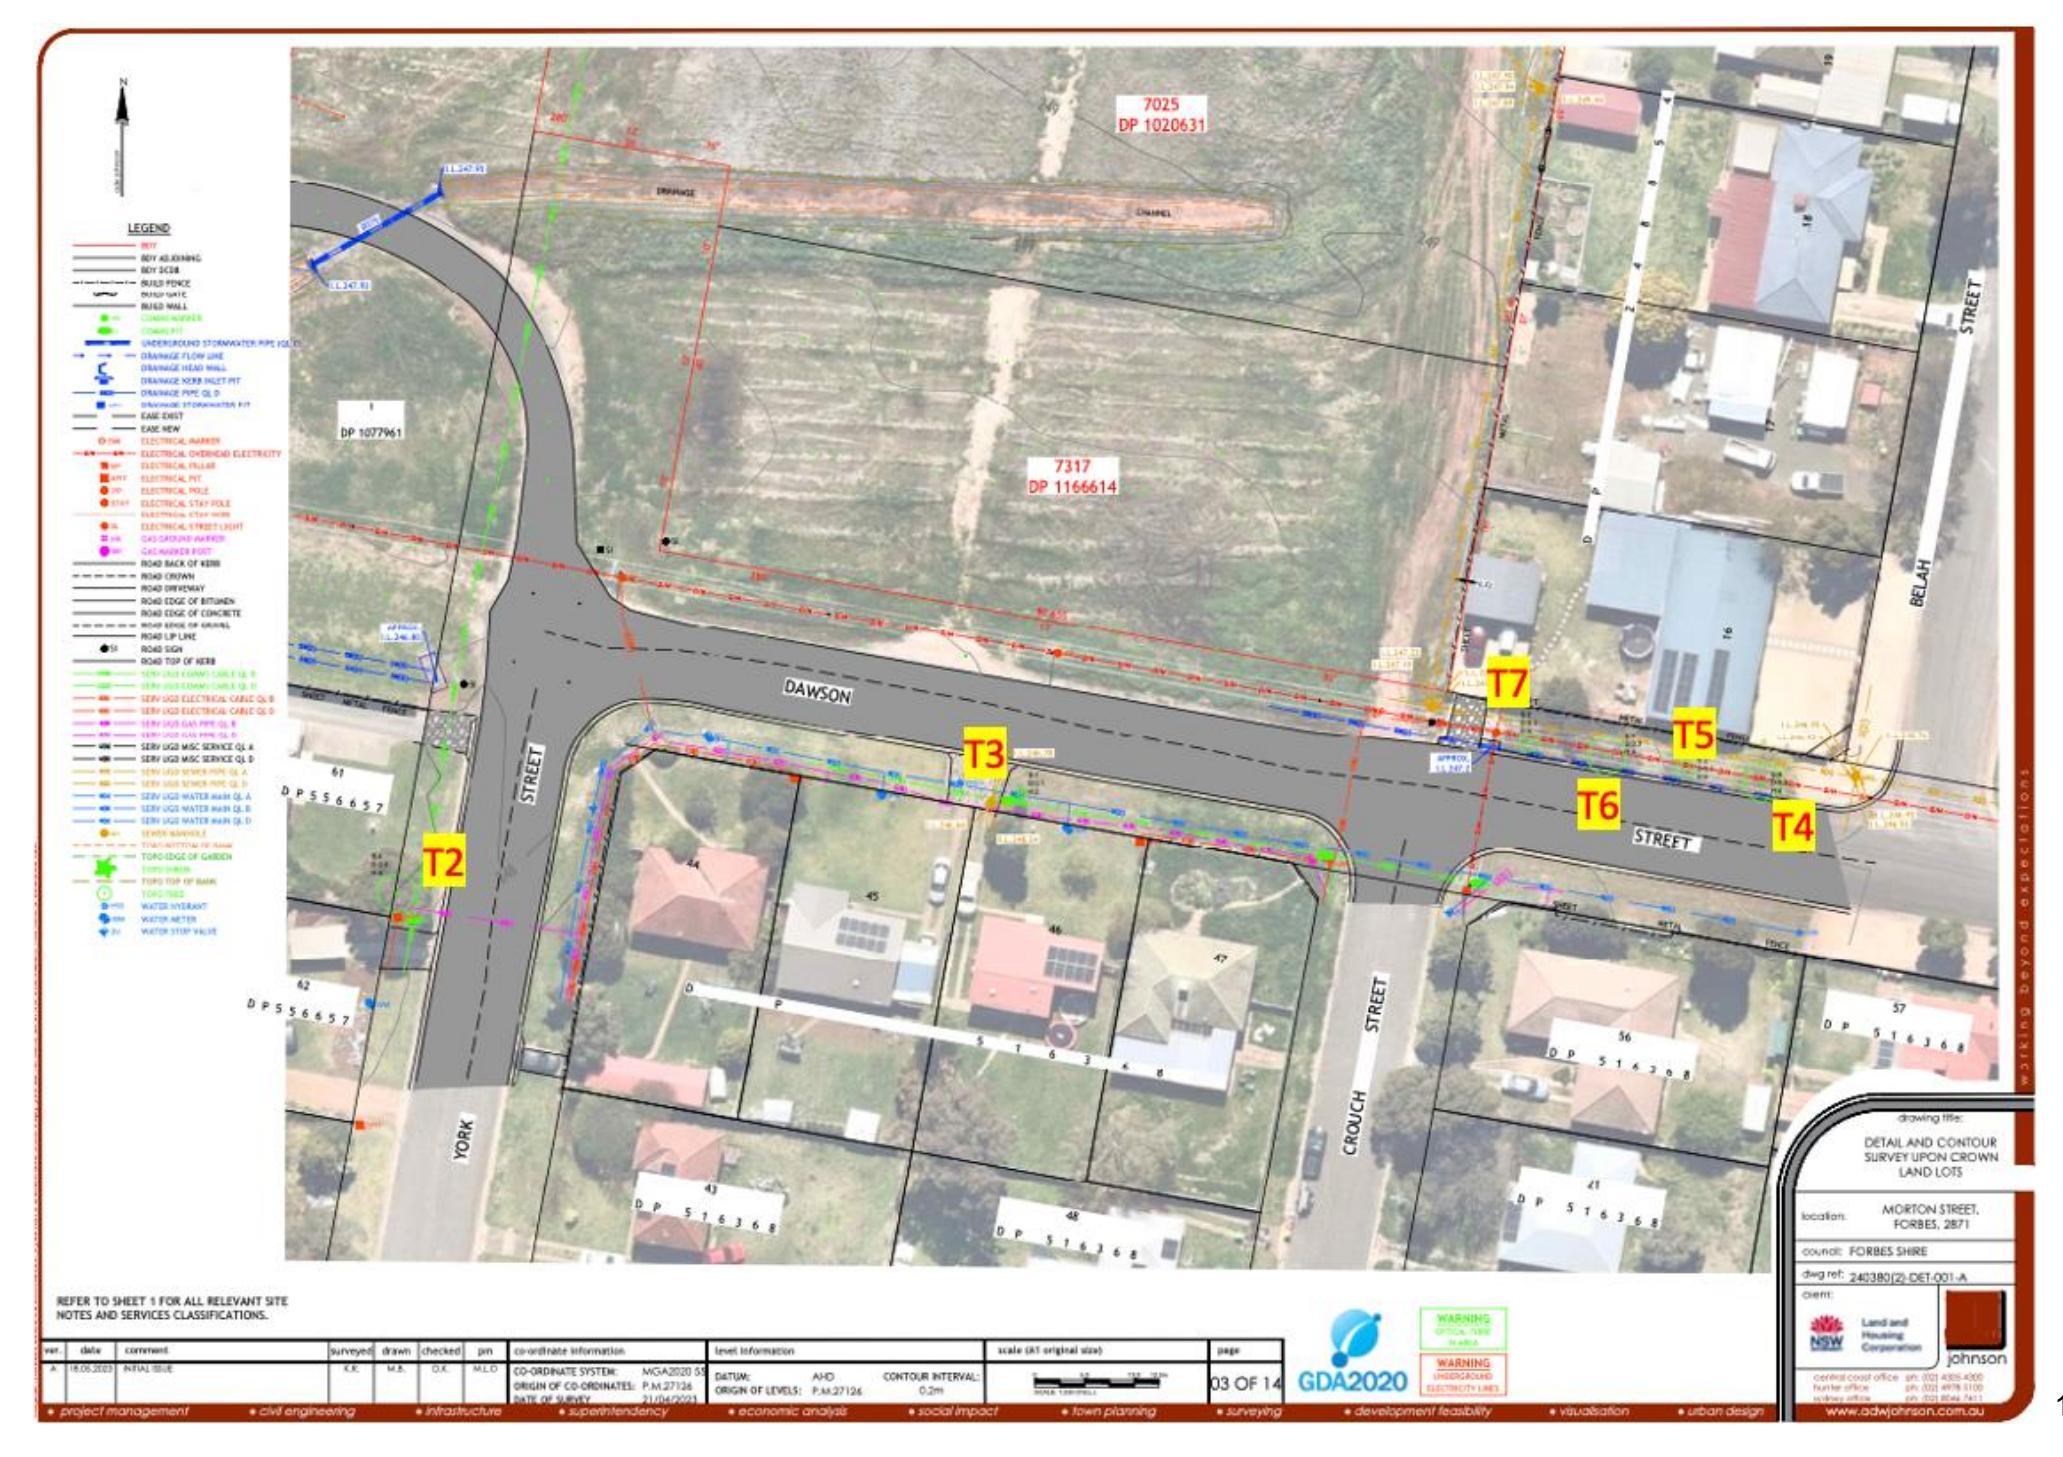
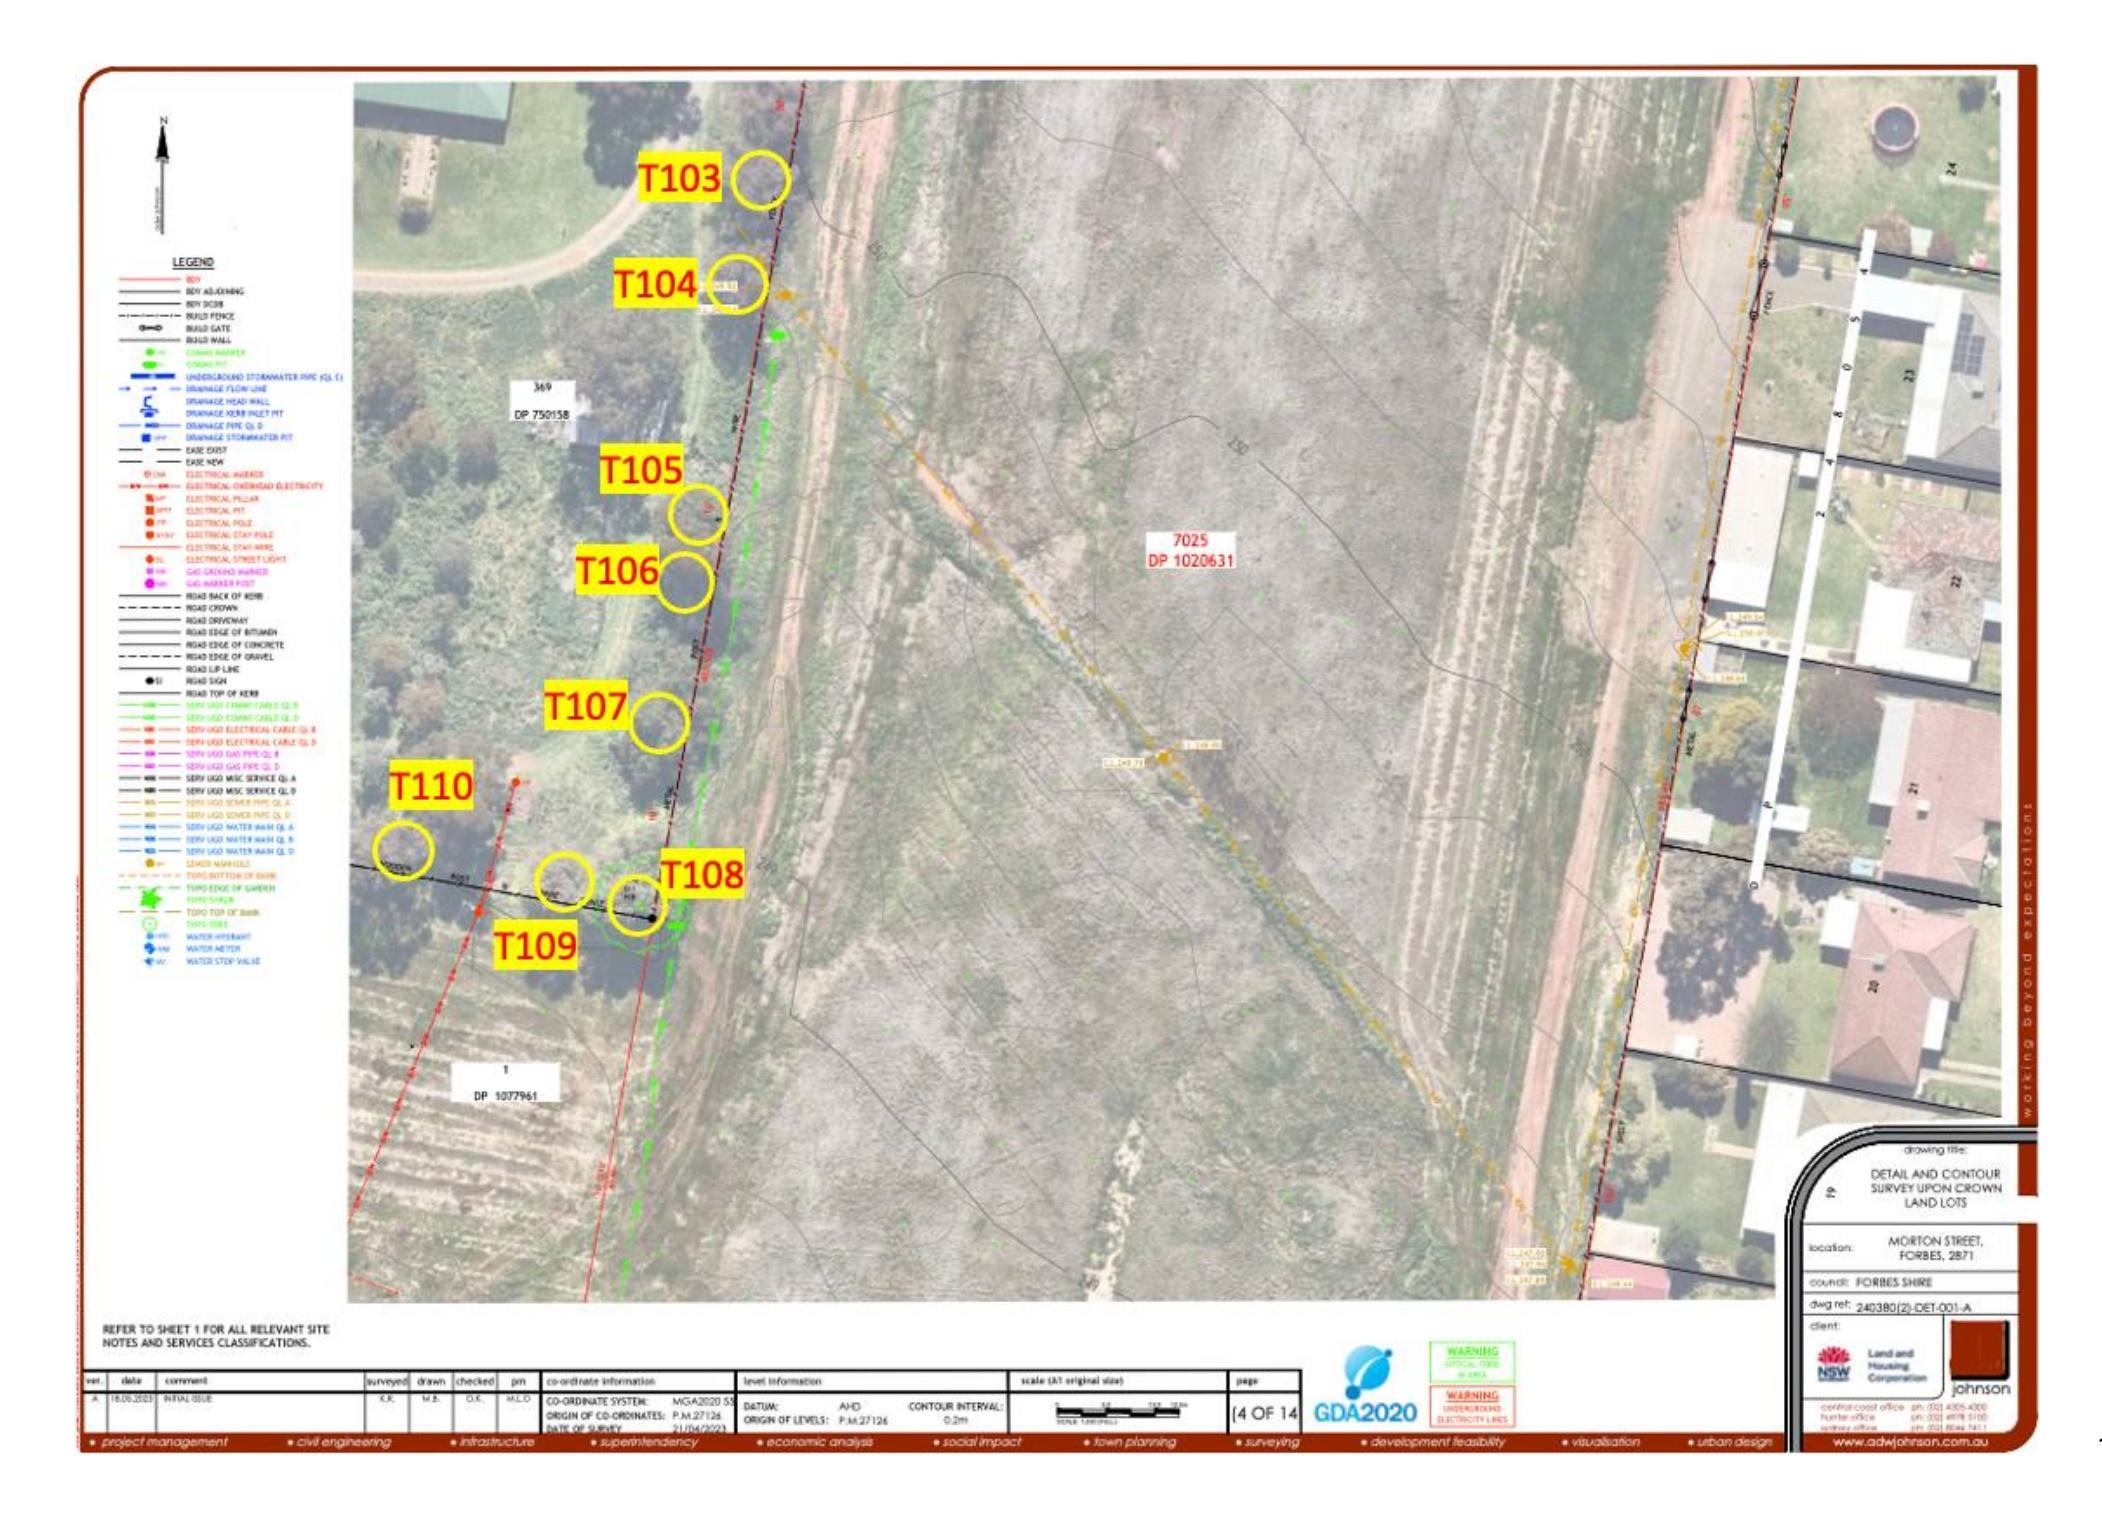
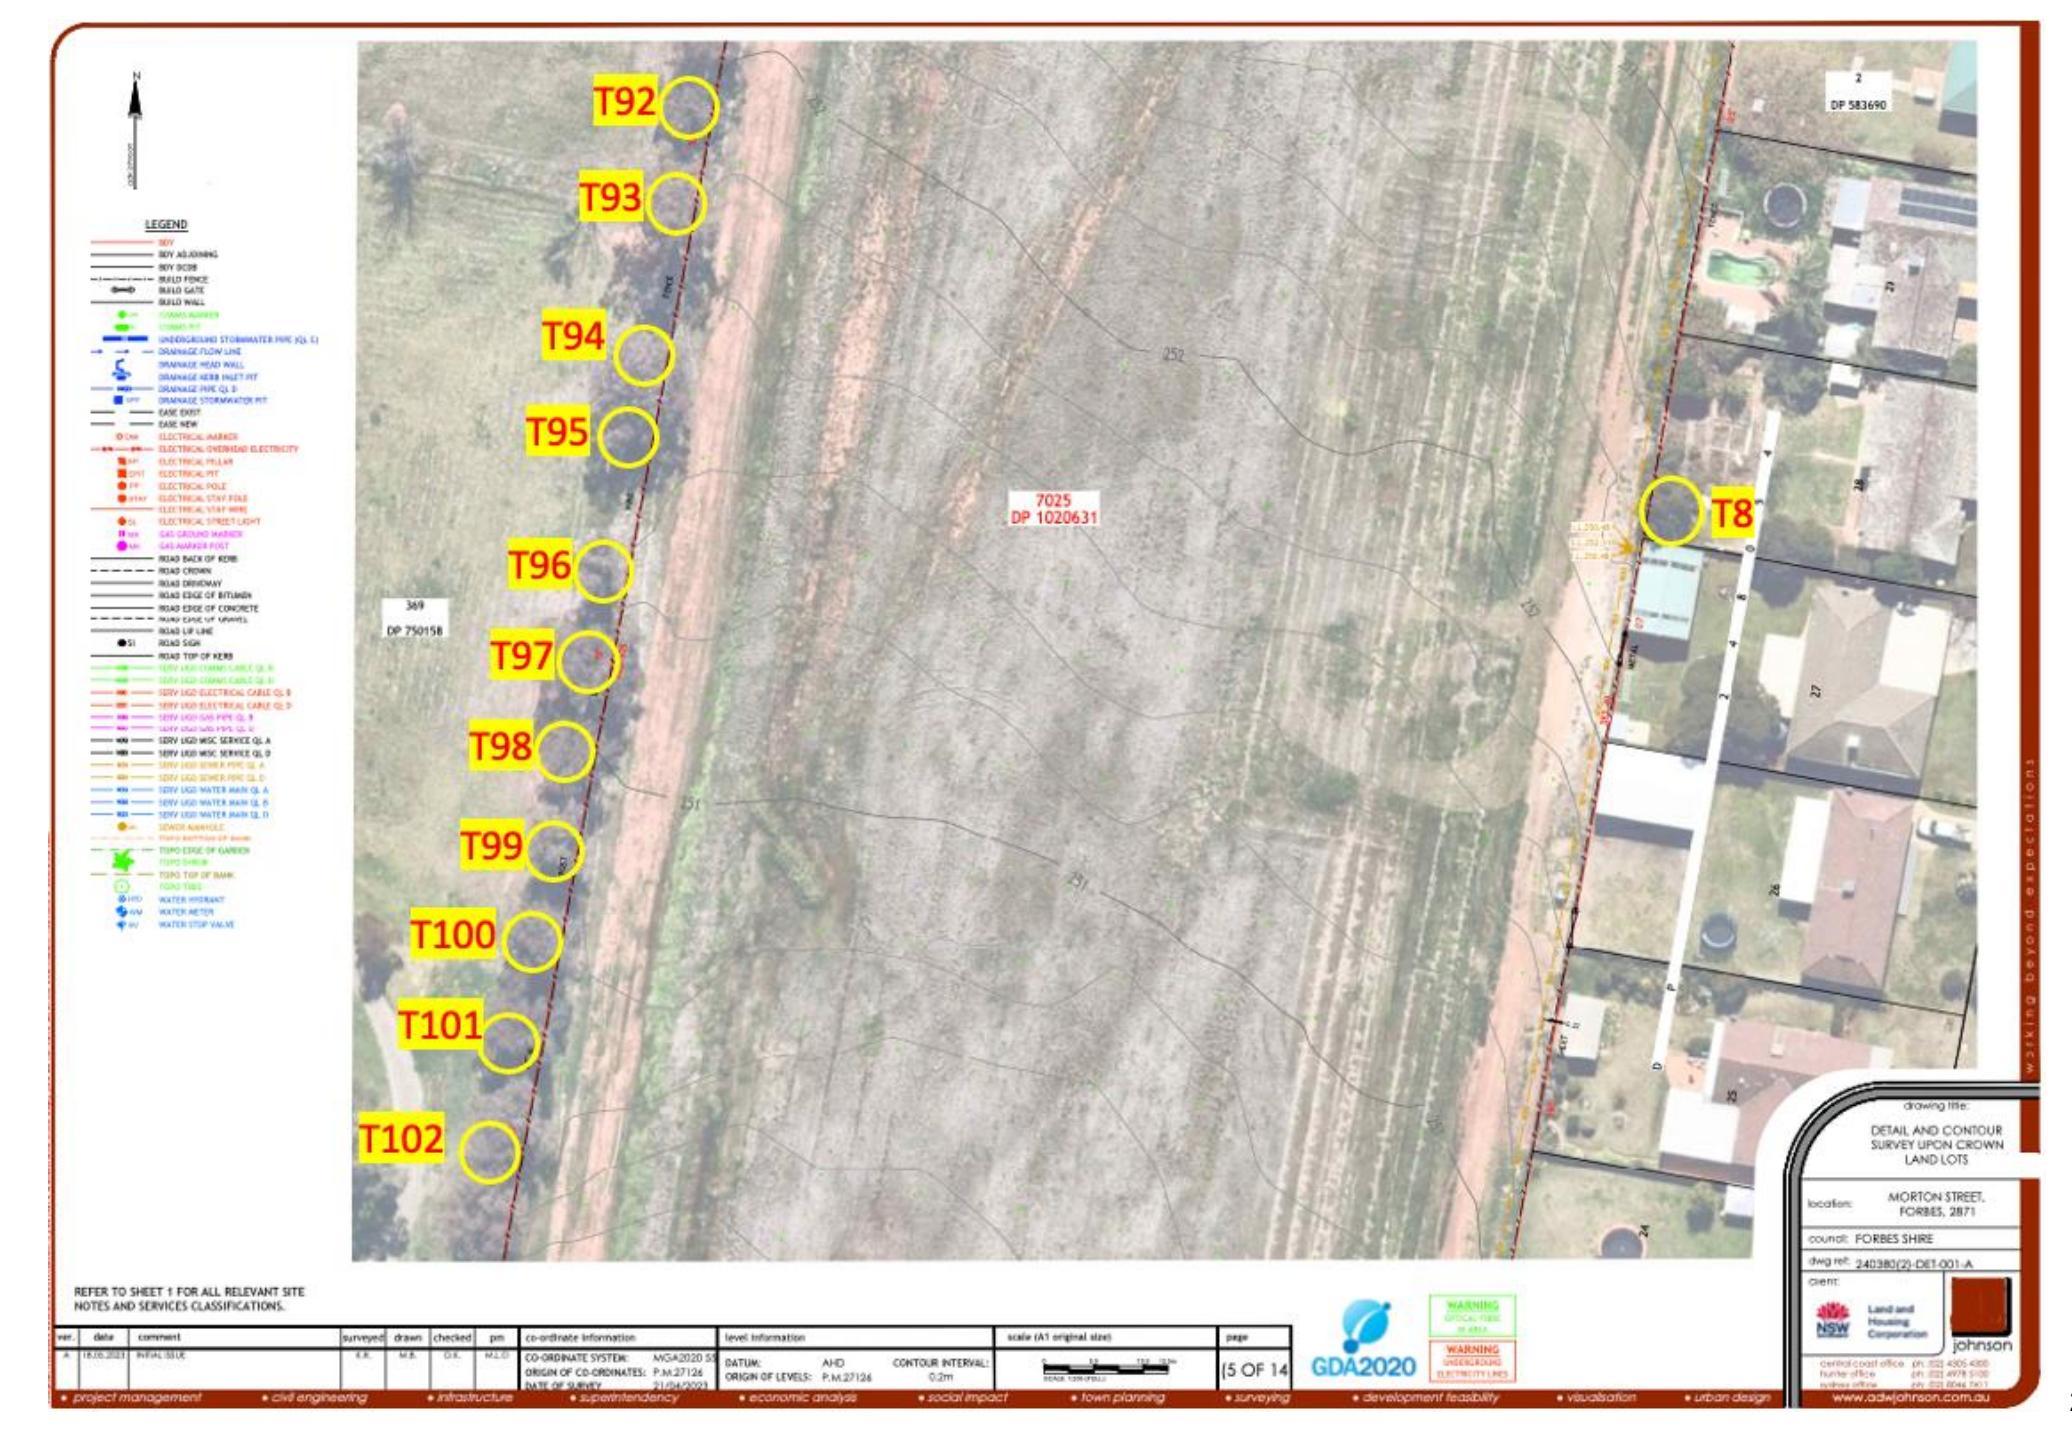
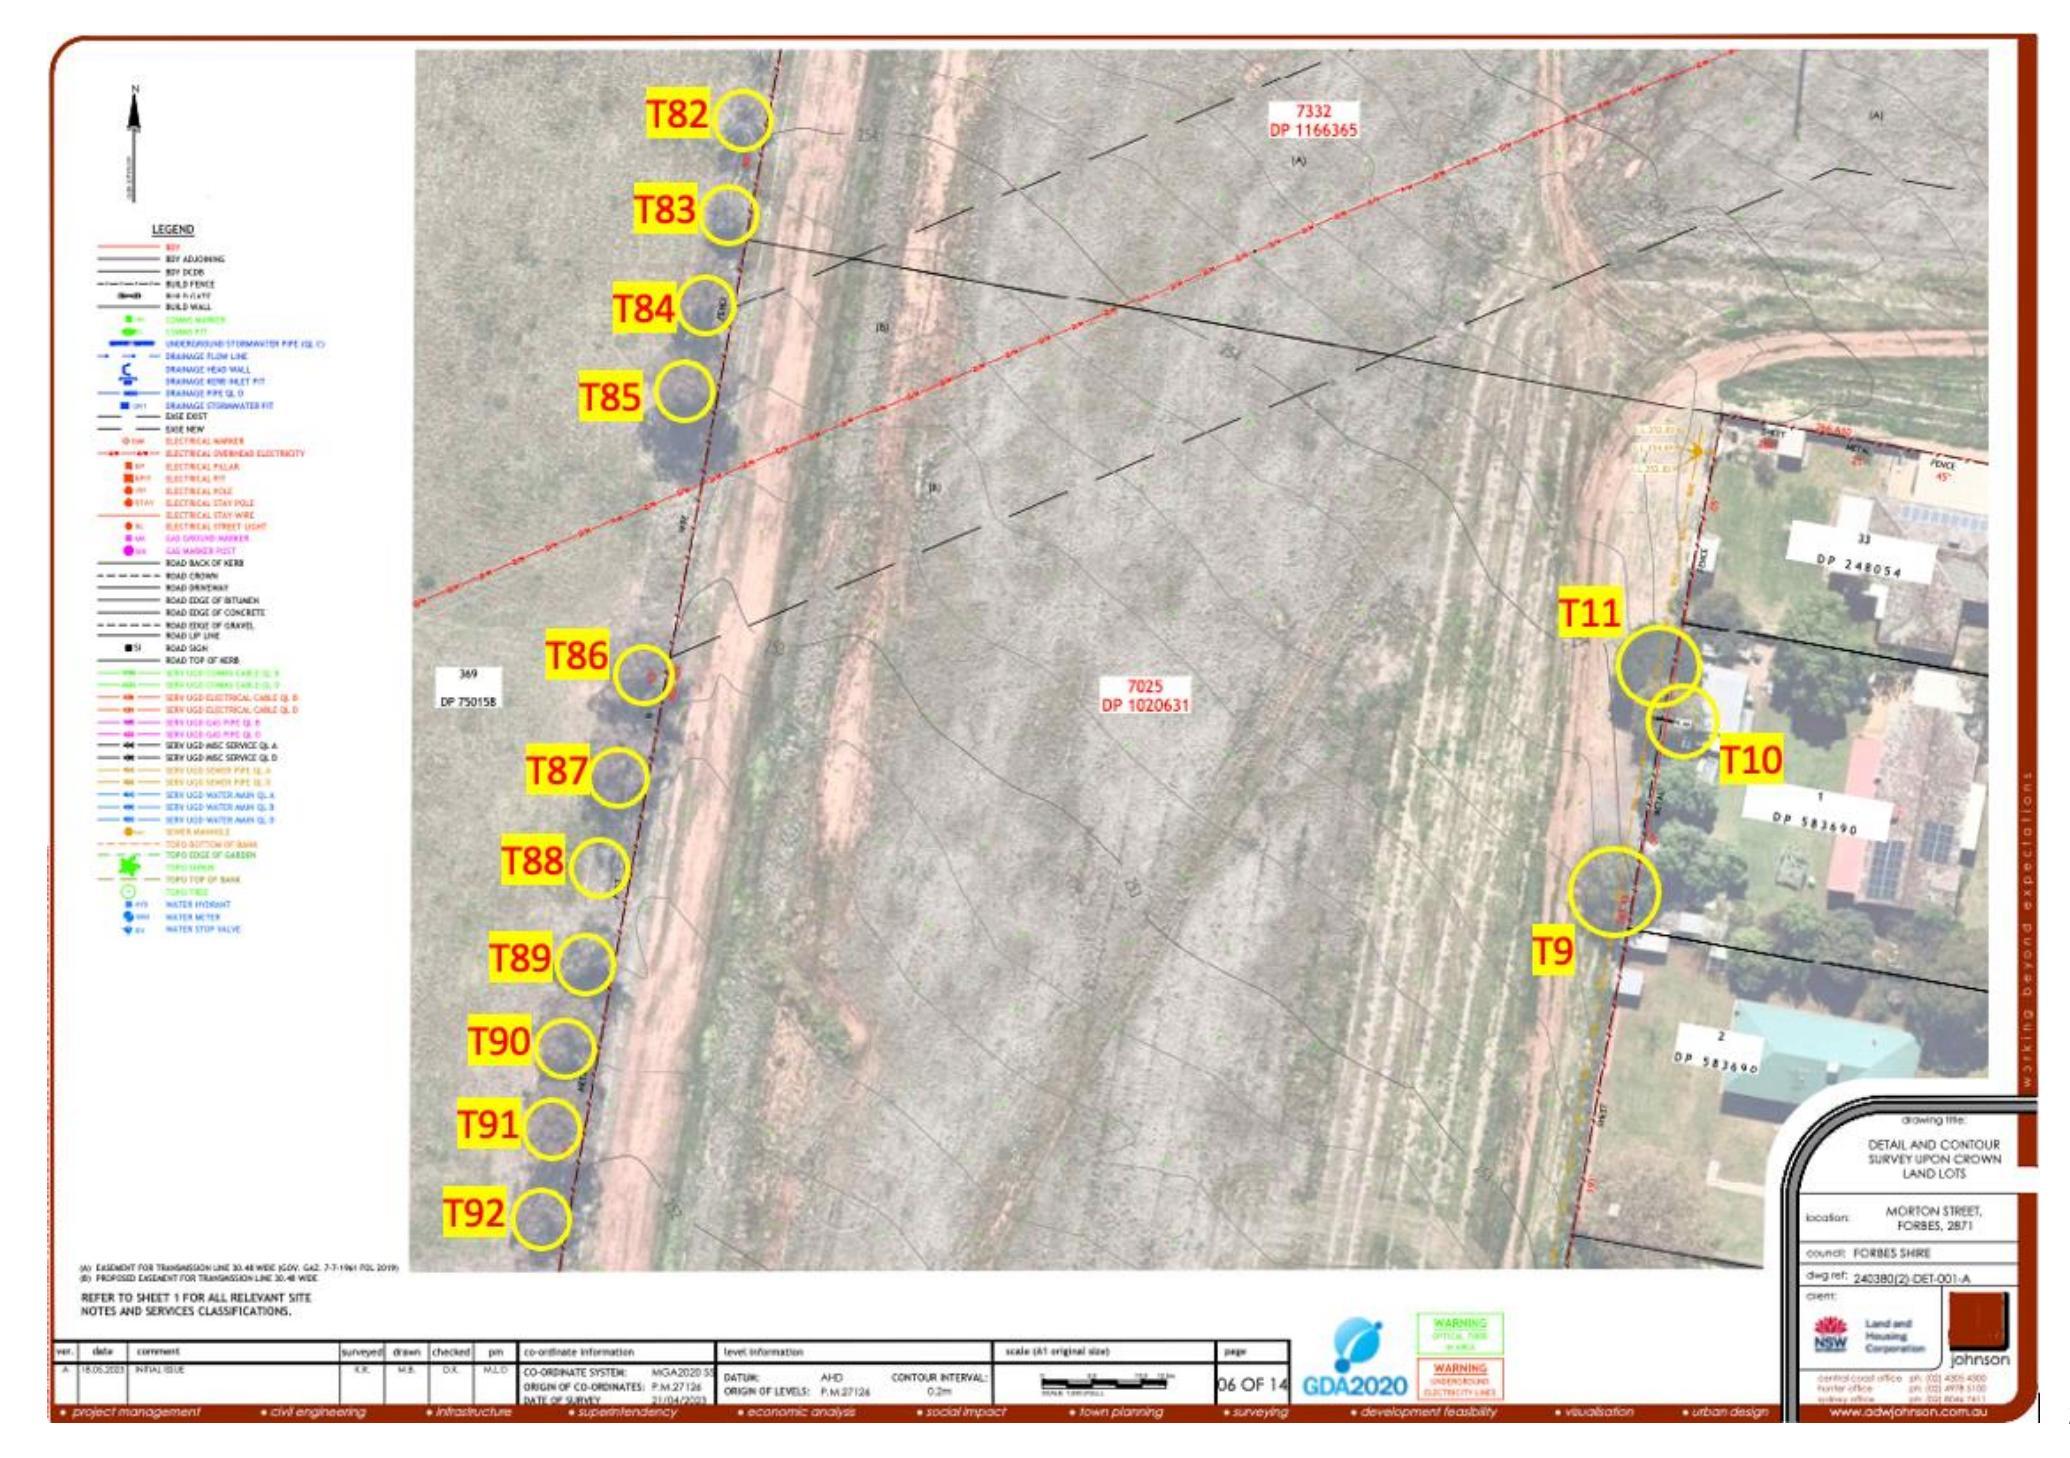
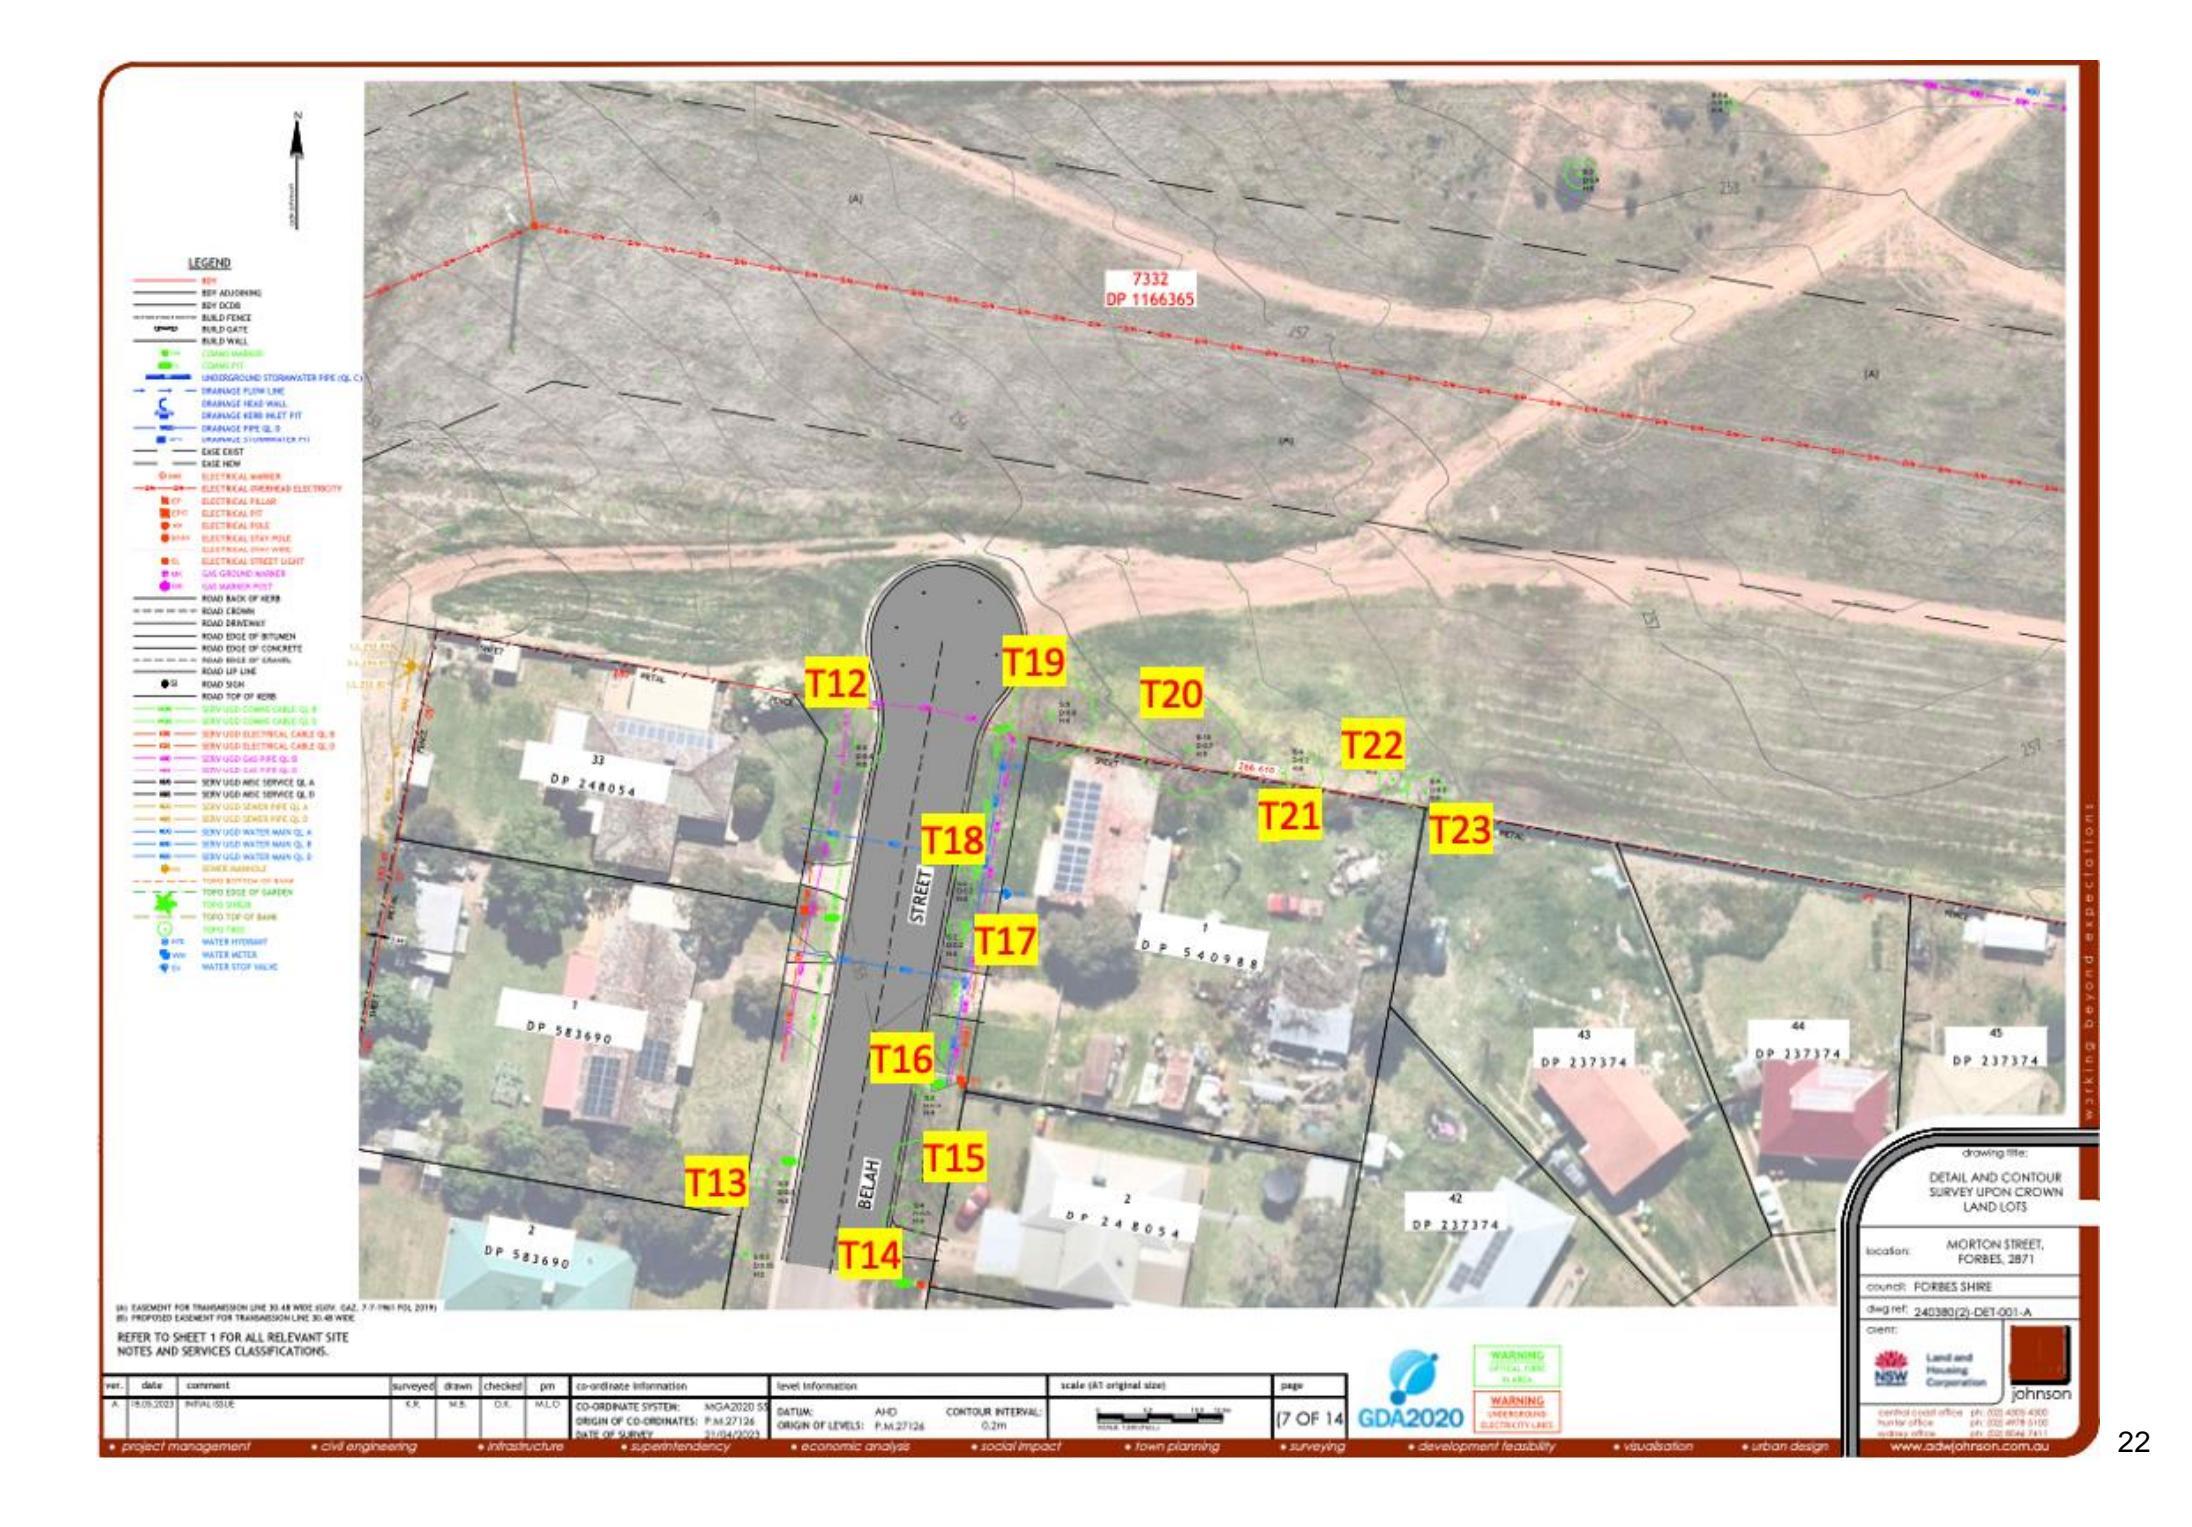
APPENDIX 2 - TREE LOCATION PLAN

Refer to Appendix 1 for detailed tree data and Appendix 2 for the Tree Location Plan.

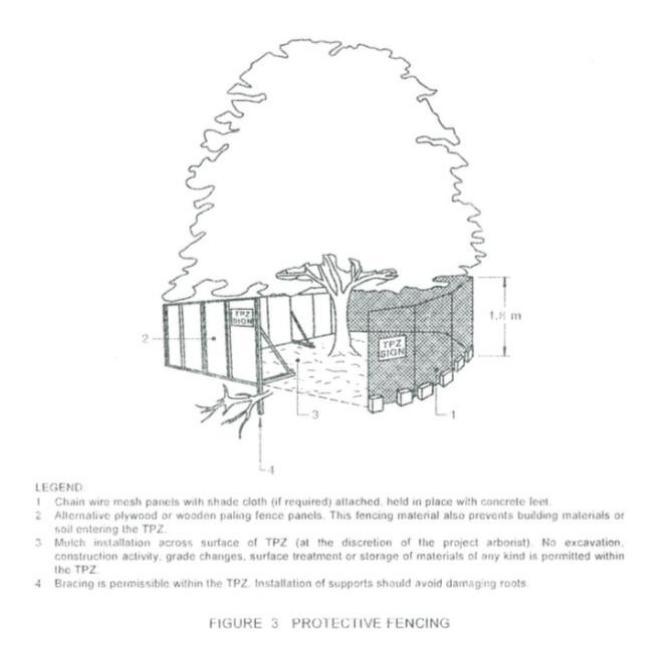
- The protective fence should be constructed from ridged chain wire mess panels (or similar), 1.8m in height, and securely anchored without penetrating the ground. An example from AS4970-2009 is shown below.

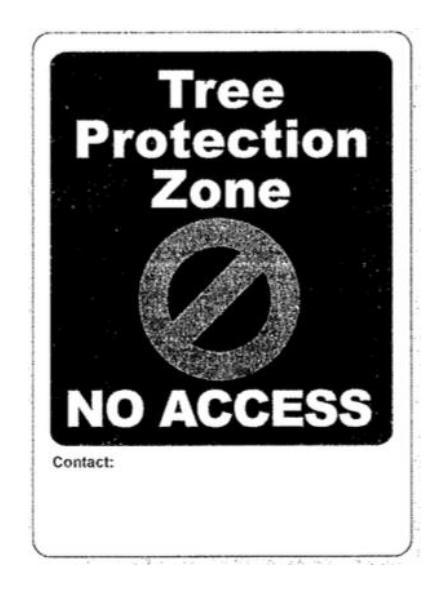
- Signs identifying the TPZ should be placed on the fencing and be visible from within the development site from all angles. An example from AS4970-2009 is shown below.
